From Tufte, Edward. *Visual Explanations: Images and Quantities, Evidence and Narrative*. Cheshire, CT: Graphics P, 1997.

The Decision to Launch the Space Shuttle Challenger

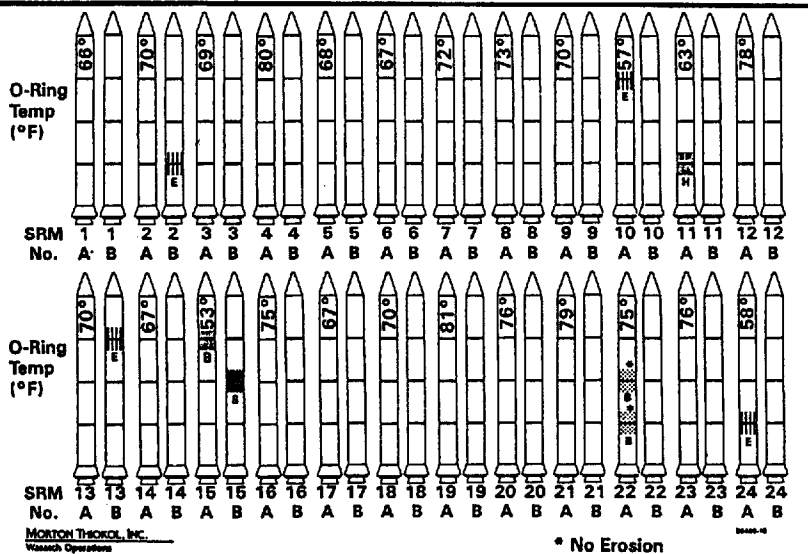
History of O-Ring Damage in Field Joints (Cont)

Chartjunk Good design brings *absolute attention* to data. Yet instead of focusing on a possible link between damage and temperature—the vital issue here—the strongest visual presence in this graph is the clutter generated by the outlines of the 48 little rockets. The visual elements bounce and glow, as heavy lines activate the white space, producing visual noise. Such misplaced priorities in the design of graphs and charts should make us suspicious about the competence and integrity of the analysis. Chartjunk indicates statistical stupidity, just as weak writing often reflects weak thought: “Neither can his mind be thought to be in tune, whose words do jarre,” wrote Ben Jonson in the early 1600s, “nor his reason in frame, whose sentence is preposterous.”⁴²

Lack of Clarity in Depicting Cause and Effect Turning the temperature numbers sideways obscures the causal variable. Sloppy typography also impedes inspection of these data, as numbers brush up against line-art. Likewise garbled is the measure of effect: O-ring anomalies are depicted by little marks—scattered and opaquely encoded—rather than being totaled up into a summary score of damage for each flight. Once again Jonson’s Principle: these problems are more than just poor design, for a lack of visual clarity in arranging evidence is a sign of a lack of intellectual clarity in reasoning about evidence.

Wrong Order The fatal flaw is the *ordering* of the data. Shown as a time-series, the rockets are sequenced by date of launching—from the first pair at upper left SRM No. 1 A B to the last pair at lower right 24 A B (the launch immediately prior to Challenger). The sequential order conceals the possible link between temperature and O-ring damage, thereby throwing statistical thinking into disarray. The time-series

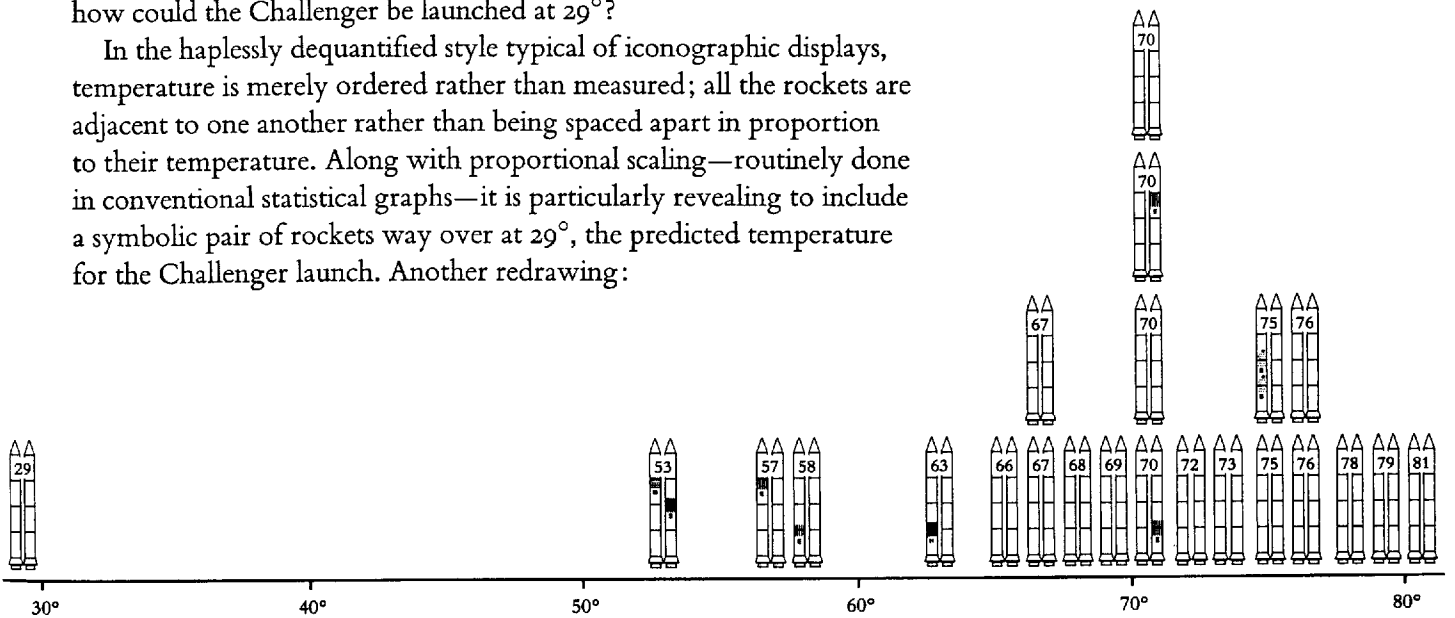
In the haplessly dequantified style typical of iconographic displays, temperature is merely ordered rather than measured; all the rockets are adjacent to one another rather than being spaced apart in proportion to their temperature. Along with proportional scaling—routinely done in conventional statistical graphs—it is particularly revealing to include a symbolic pair of rockets way over at 29°, the predicted temperature for the Challenger launch. Another redrawing:

Even after repairs, the pictorial approach with cute little rockets remains ludicrous and corrupt. The excessively original artwork just plays around with the information. It is best to forget about designs involving such icons and symbols—in this case and, for that matter, in nearly all other cases. These data require only a simple scatterplot or an ordered table to reveal the deadly relationship.

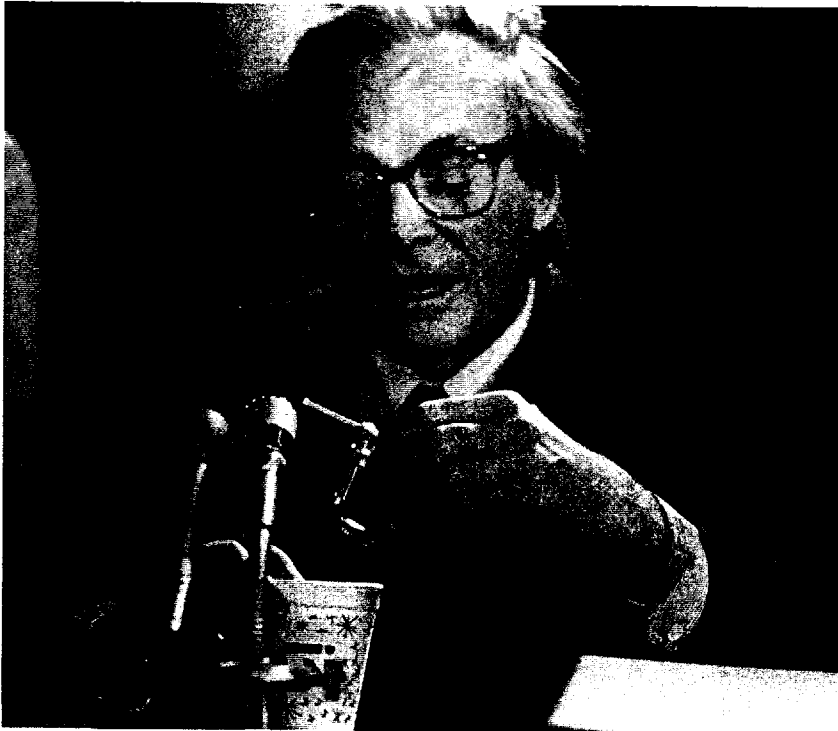
At a meeting of the commission investigating the shuttle accident, the physicist Richard Feynman conducted a celebrated demonstration that clarified the link between cold temperature and loss of resiliency in the rubber O-rings. Although this link was obvious for weeks to engineers and those investigating the accident, various officials had camouflaged the issue by testifying to the commission in an obscurantist language of evasive technical jargon.⁴³ Preparing for the moment during the public hearing when a piece of an O-ring (from a model of the field joint) would be passed around, Feynman had earlier that morning purchased a small clamp at a hardware store in Washington. A colorful theater of physics resulted. Feynman later described his famous experiment:

I take the clamp out, hold it in the air, and loosen it as I talk: "I discovered that when you undo the clamp, the rubber doesn't spring back. In other words, for more than a few seconds, there is no resilience in this particular material when it is at a temperature of 32 degrees. I believe that has some significance for our problem."⁴⁴

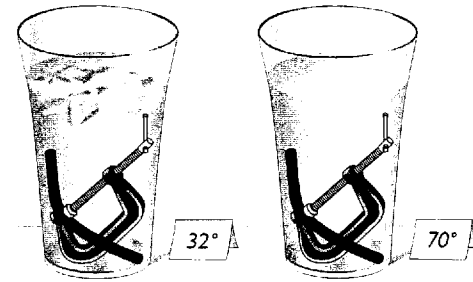
⁴⁸ Feynman was aware of the problematic experimental design. During hearings in the afternoon following the ice-water demonstration, he began his questioning of NASA management with this comment: "We spoke this morning about the resiliency of the seal, and if the material weren't resilient, it wouldn't work in the appropriate mode, or it would be less satisfactory, in fact, it might not work well. I did a little experiment here, and *this is not the way to do such experiments*, indicating that the stuff looked as if it was less resilient at lower temperatures, in ice." (PCSSCA, volume IV, pp. 739-740, transcript, emphasis added.) Drawing of two-glass experiment by Weilin Wu and Edward Tufte.
